Rain and Flood Gage Readings

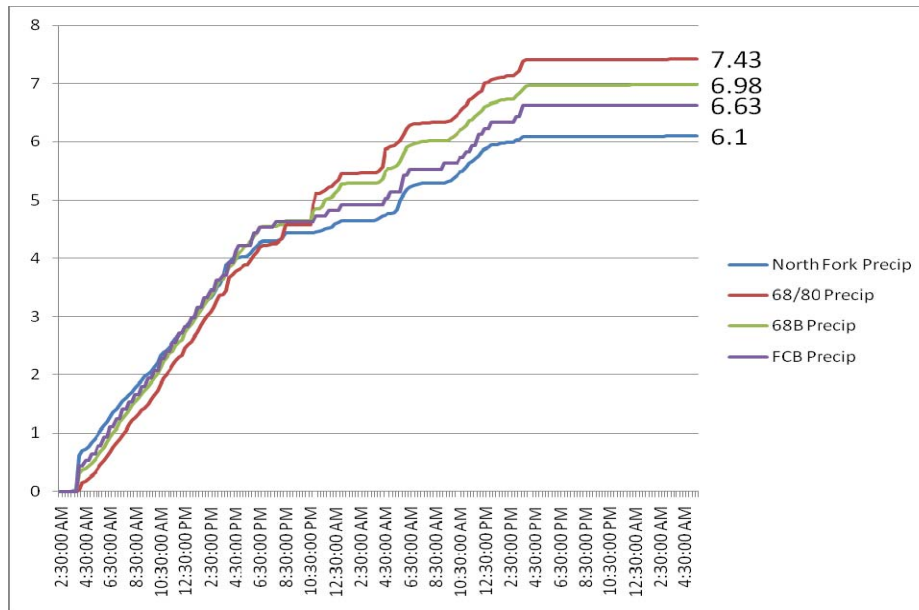
Rainfall amounts for the period Saturday, May 1 to Sunday, May 2 varied between 7.43 inches at our electronic streamflow gage on US 68/80 East (Moseley Bridge), to 6.1 inches at our streamflow gage on the North Fork at Jeffers Bend. From 4:30 AM and Saturday to 4:30 AM on Sunday, the gage at Moseley Bridge logged 5.73 inches of rain. A 100-year, 24-hour storm event is equal to 6.8 inches or rain in a 24-hour period.

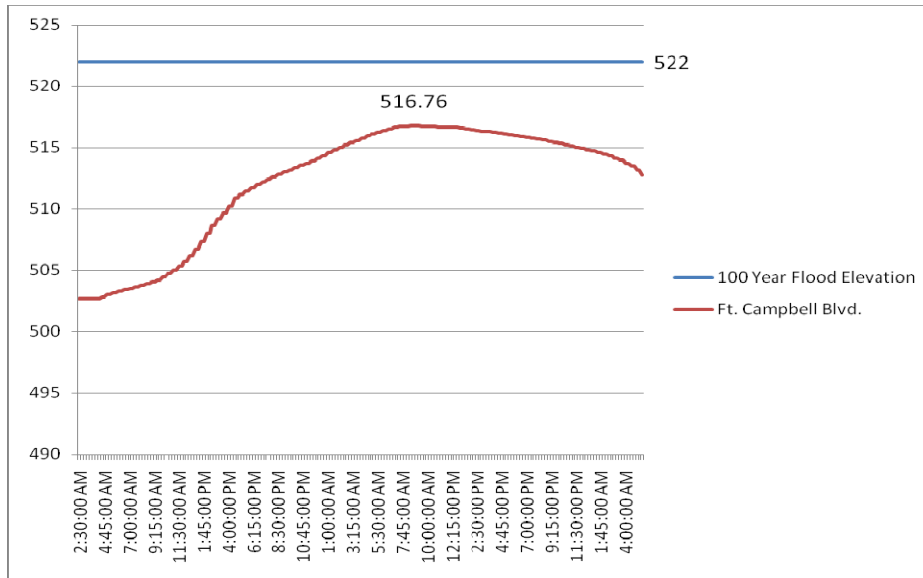
The South Fork of the Little River crested at Ft. Campbell Blvd. at approximately 9:15 on Sunday morning after 5.63 inches of rain, even though it continued to rain into the afternoon, totaling 6.63 inches by 3:30 Sunday afternoon. There were multiple crests at Moseley's Bridge on 68 East. The largest crest came at 7:15 Saturday evening, with smaller crests occurring at 2:00 and 8:00 on Sunday morning, and the final crest coming at 2:30 on Sunday afternoon.

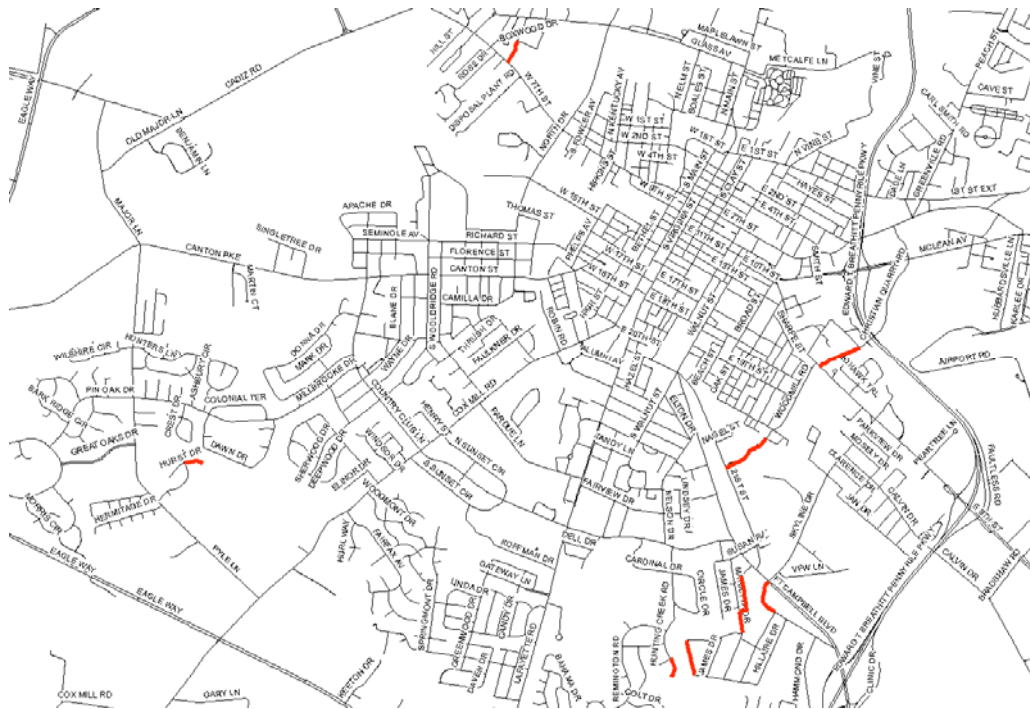
County personnel responded late Monday night and closed several roads along the South Fork including Little River Church Road, and L. Thompson Road. Early Sunday morning, lower portions of Woodmill Road, Christian Quarry Road, and Old Clarksville Pike Road behind Walgreens were covered in floodwaters. This flooding was closely followed by the inundation of Marietta Bridge, S. Riverwood Drive, and portions of N. Michael Drive. Across the river, Hunting Creek Court was also covered in water, yet passable.

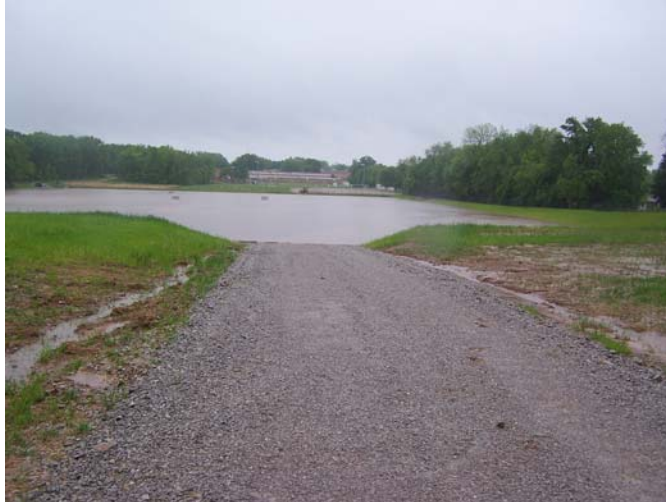
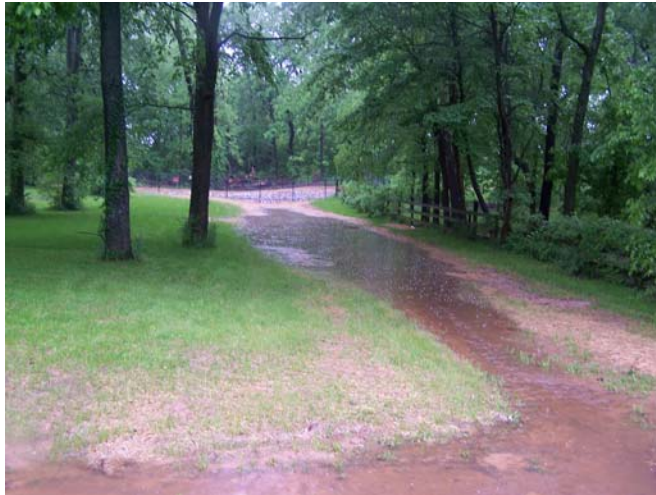
South Sunset Circle

The basin constructed on the Shelton property is a success story. At no point during the event did rain waters surround foundations of homes or substantially inundate yards. The water elevation of the basin reached the emergency spillway at 524’.

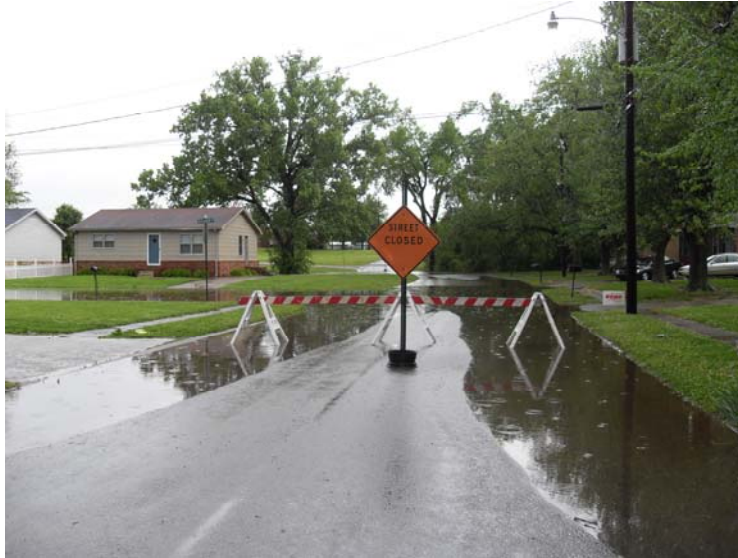
Westwood/Boxwood

There was a road closure necessary on Westwood Drive, though it did not appear that any foundations were substantially affected by rain waters.

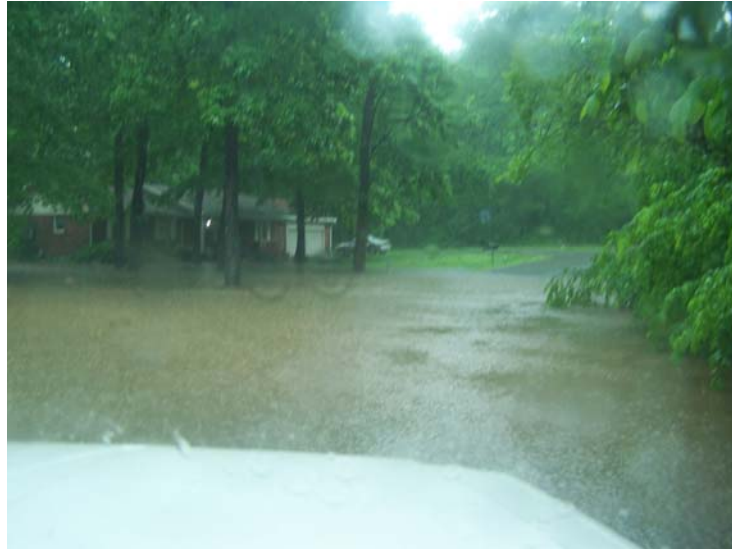
Hurst Drive

Rain Waters necessitated a closure of Hurst Drive, and reached the foundation of 912 Hurst Drive.
